After 31 Years in Atlantic Ocean Outfall, RCP Still Exceeds Specs¹

History of the 30-Year Old RCP

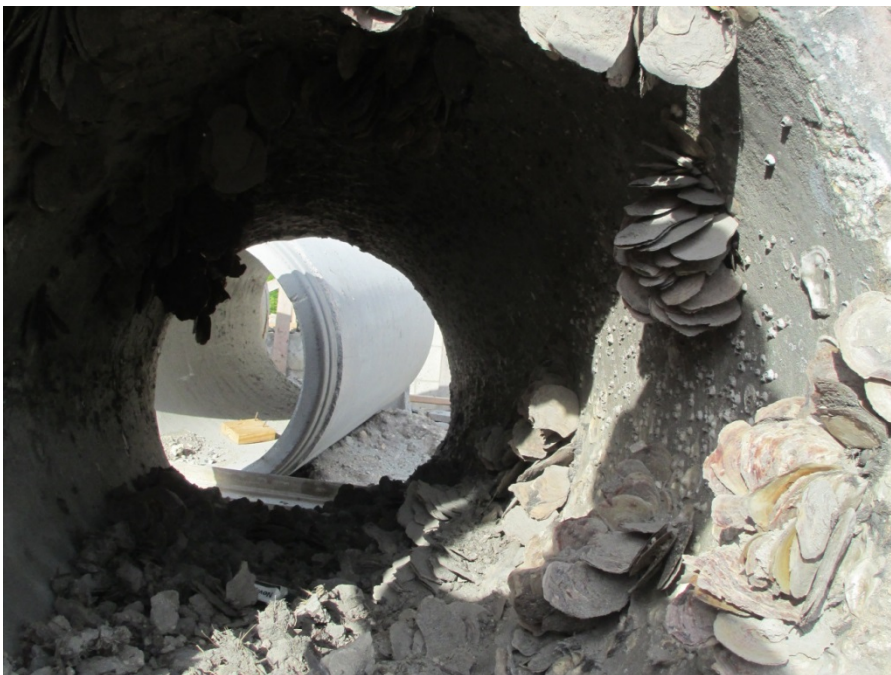
Figure 1. Barnacles attached to the inside barrel of concrete pipe after 30-years in the tidal Dania Beach marina.

Rinker observed the 30-year old RCP to be of sound structural condition.⁴ In order to examine the reinforcement, a rectangular 1-foot by 2-foot section was cut from the pipe wall. Some of the steel had visible signs of corrosion but no concrete appeared corroded or spalled. Minor corrosion stains were visible at the longitudinal tips in the bell face. The inside barrel of each pipe was covered in barnacles.

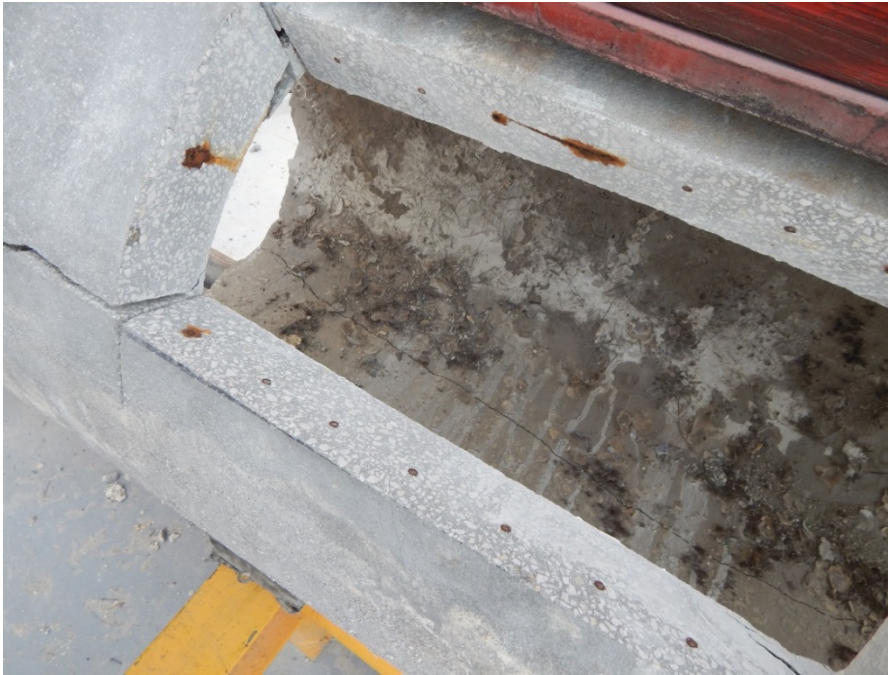
Figure 2. A 1-foot by 2-foot section was cut from the barrel to observe and measure steel reinforcement. Minor steel corrosion was observed, but with no damage to the adjacent concrete.

⁵ Prior to loading the pipe, Rinker had removed a 1-foot x 2-feet coupon in order to examine the cross-section. Using a micrometer gauge, circumferential steel was measured to be 0.24 inch diameter at 3-inch spacing, and thus resulting in a reinforcing area of 0.18 sq.in./ft., which is the minimum steel reinforcing area required per ASTM C76 Class III B-Wall 30-inch RCP. The Class III design load target is 1,350 pounds per foot diameter per foot length(lbs/ft/ft), and the yield load target is 2,000 lbs/ft/ft. Therefore, the target design and yield loads for the 30-inch (1.5 feet) diameter and 6.6-feet length test pipe were calculated to be 22,300 pounds and 33,000 pounds, respectively.

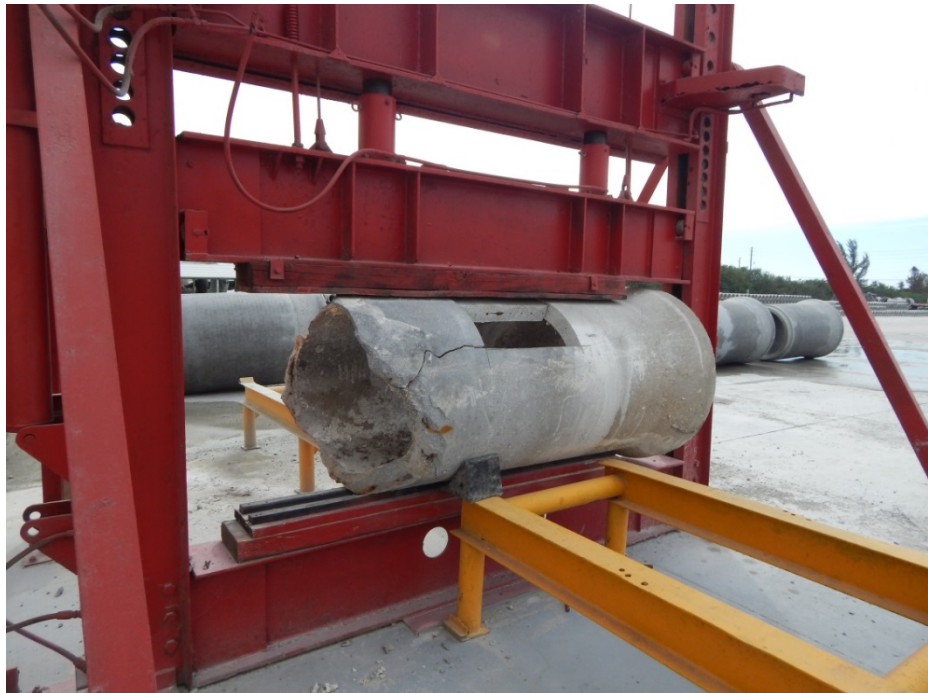
minimum design and yield loads for the applicable ASTM C 76 strength class (e.g., Class III). It is noteworthy that the 30-year old RCP had not only been setting in tidal seawater for 30 years but also was tested with a 1x2 feet section removed from its barrel wall. For the 30-year old RCP, the minimum design and yield load targets were determined to be 22,300 pounds (and 33,000 pounds, respectively).⁵

The initial hairline crack (< 0.01 inch wide) was not observed until 36,000 pounds had been loaded on the 30-year old RCP. A 0.01-inch wide crack did not develop until 42,000 pounds, and the old RCP did not yield until 51,600 pounds. The old RCP – after 30-years of service in tidal conditions and then having a large section cut from its wall – still exceeded the design service load (0.01-inch crack) by a factor of 1.9 and exceeded the yield load by a factor of 1.6 times.

Figure 3. A three-edge bearing (3EB) strength load test was conducted on a 30-year old section of RCP that had been removed from a tidal marina. Prior to loading, a section was removed from the wall for examination. Despite this, the RCP was able to support 51,600 pounds. .

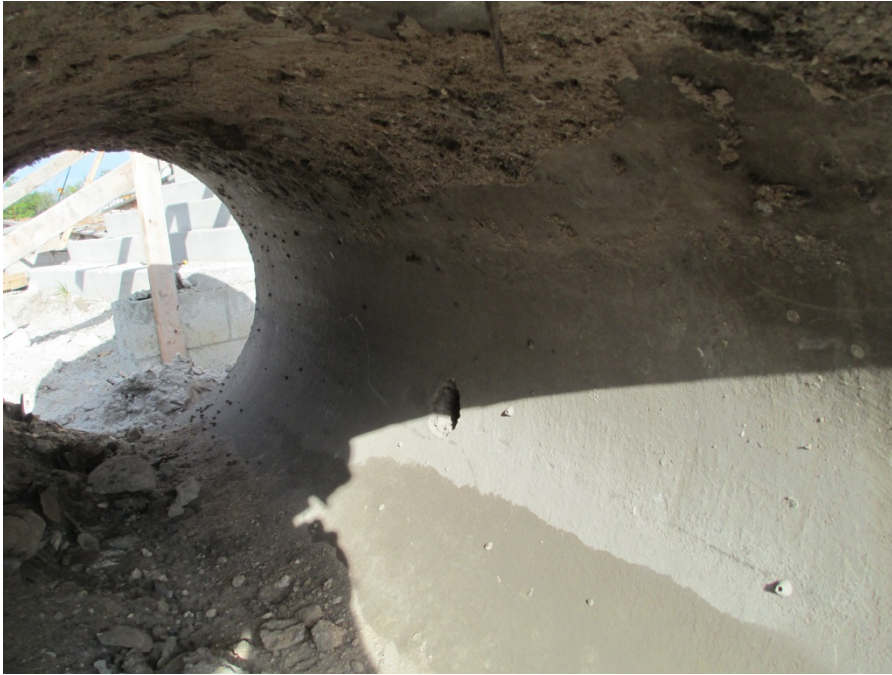
Figure 4. A lift hole, cored into the pipe at casting, is visible in the 30-year old steel reinforced concrete pipe removed from the Dania Beach marina renovation. Although installed at an outfall in a tidal seawater environment, there is no visible deterioration adjacent to the lift hole.
