A Brief History of a Concrete Pipe

Douglas Holdener, P.E.

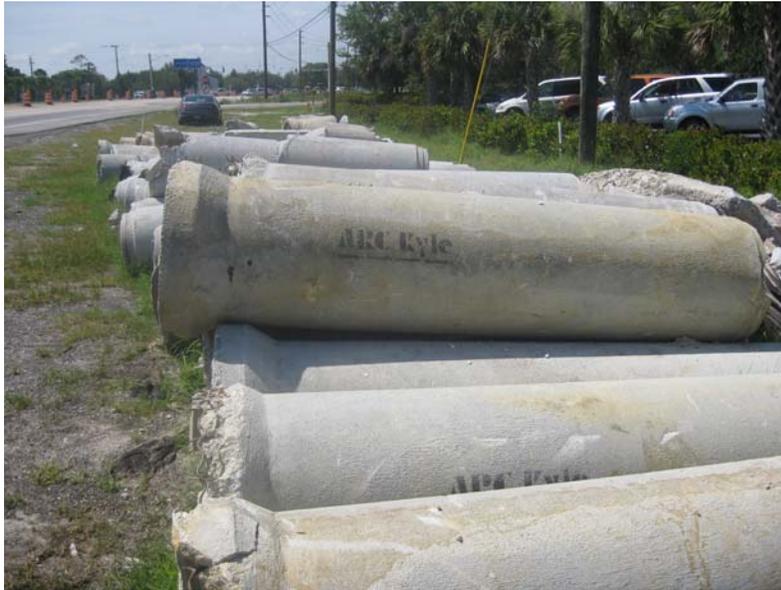
Figure 1. 32-year old RCP unearthed during US 41 highway construction in Lee County, Florida.

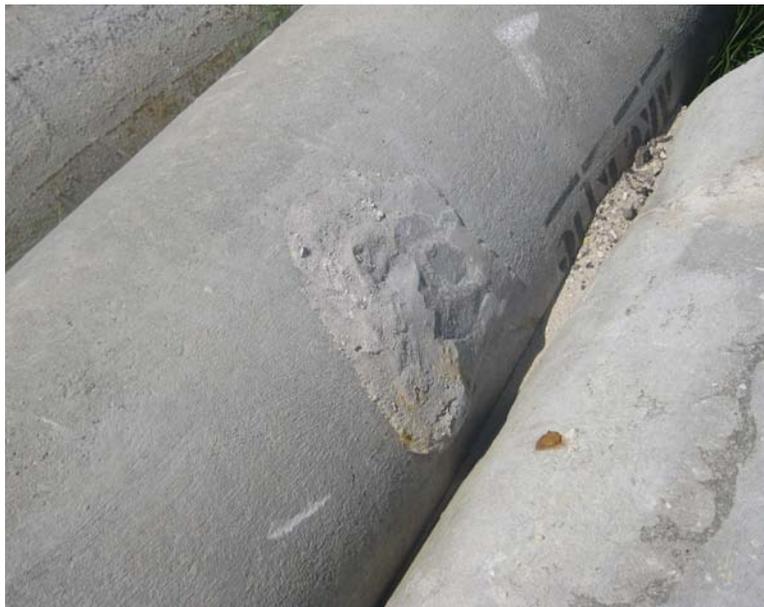
Figure 2. Lifting holes in 32-year old 18-inch RCP plugged with mortar have remained intact. The adjacent concrete pipe walls are in excellent condition.

The 15- and 18-inch diameter ARC Kyle concrete pipe unearthed along US 41 is approximately 32 years old. Despite a few damaged sections as a result of removing the old pipe with hydraulic excavators, the old RCP is in excellent condition. Neither the concrete nor the steel shows signs of corrosion, spalling, or deterioration. This pipe was installed at a time when lifting holes were plugged on the job site with objects such as Styrofoam cups, rags, or even oranges and then filled the exterior side of the hole with a mortar plug. These plugs, and the pipe wall, have withstood the test of time. The cups and oranges have since deteriorated.

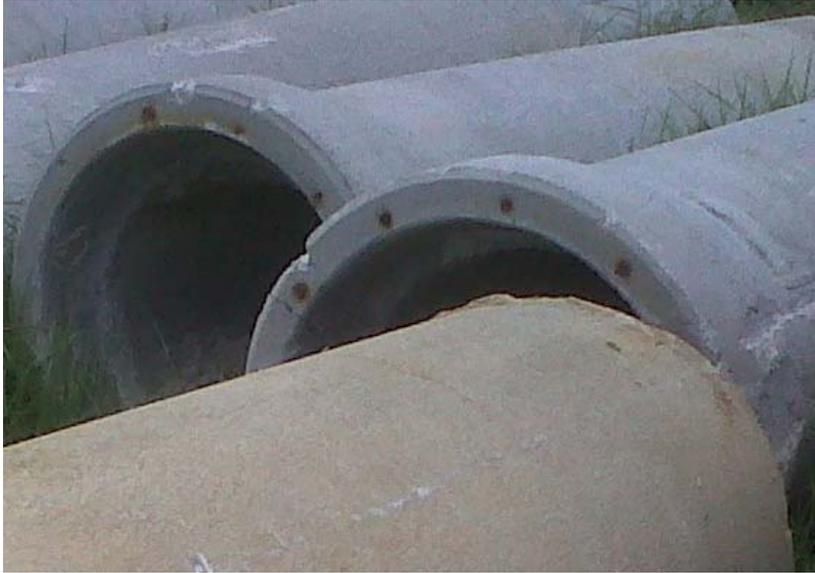
Interestingly, the longitudinal reinforcing tips are visible on the face of the bell of some of the pipe. During production, longitudinal steel was allowed to rest on the pallet, and the end tip of the longitudinal reinforcement was, therefore, visible. The visible tips are not grounds for rejection, per ASTM C 76. Even though the longitudinal end tips were directly exposed to the environment for over thirty years, there is no deterioration in these areas.

Figure 3. Exposed Longitudinal Reinforcing Tips Has Not Resulted in Corrosion or Spalling.

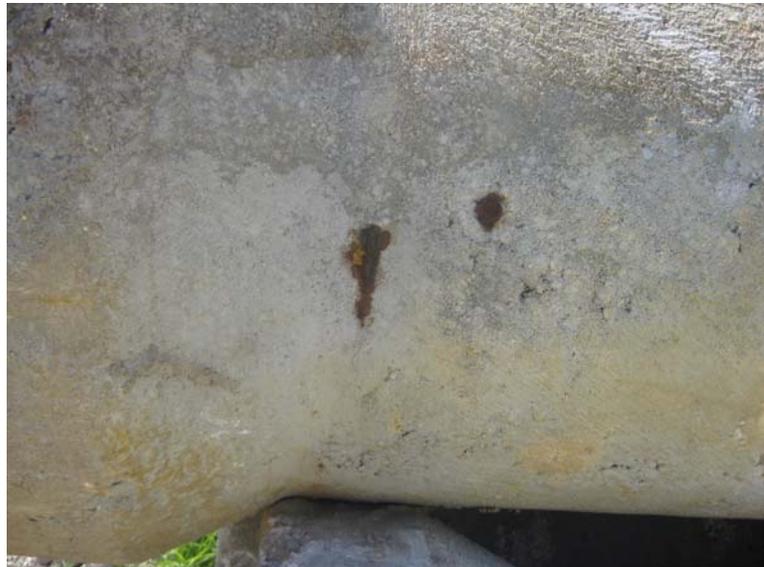
Figure 4. An exposed circumferential wire has rusted but there is no deterioration to the concrete pipe wall. This localized issue did not impact the concrete pipe's performance during its 32 years in service.
